# Test Report

Report No. A2200397792101002a

Sample Name SMA Jack Nautilus SS with Silicone O-Ring to I-Pex MHF

Type CAB412RF-0050-1-S

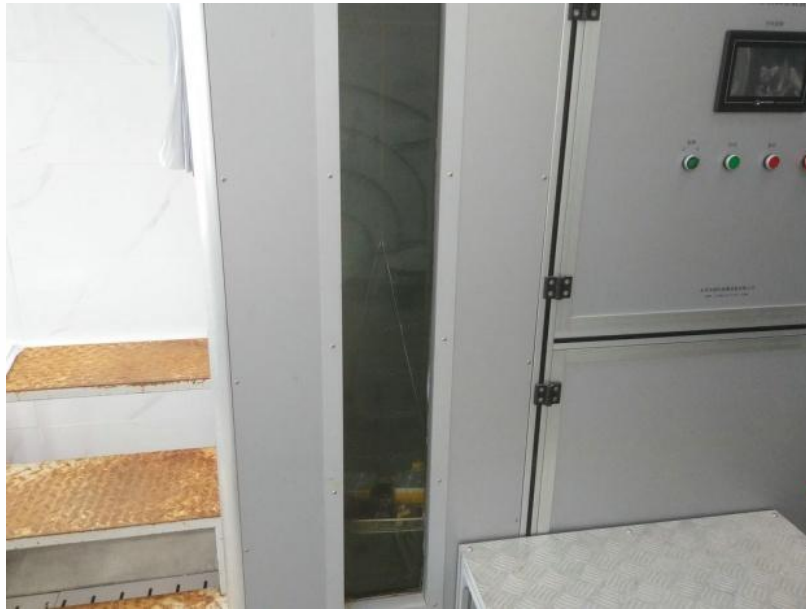
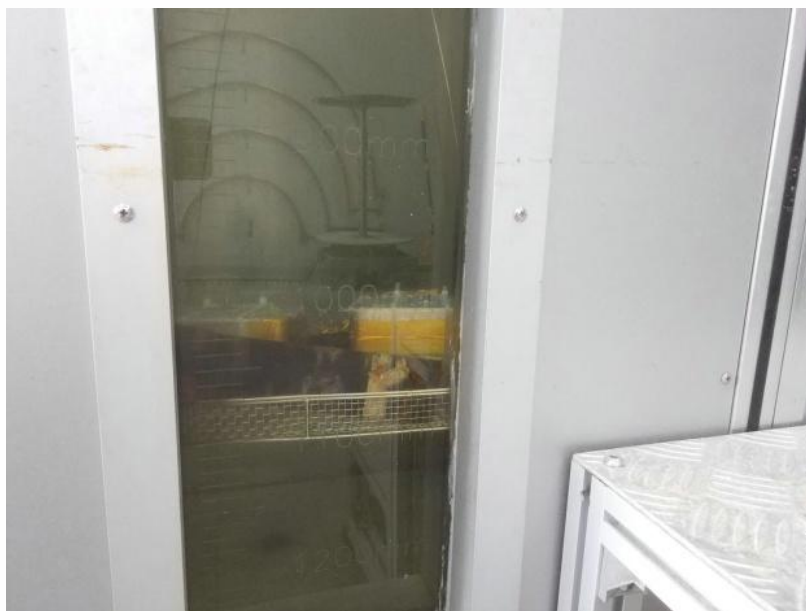
Test Set-up Photo

-a) The lowest point of the sample is located 1000 mm below the surface of the water.

The highest point of the sample is located 150 mm below the surface of the water.

-b) Test duration: 48h.

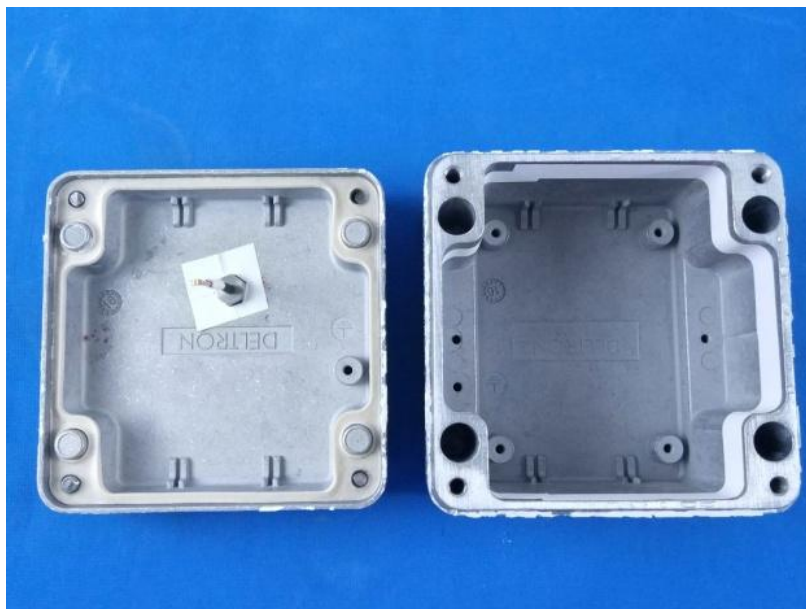
Sample No.	Result(Visual inspection)	Conclusion
A2200397792101002	No water was observed in the sample by visual inspection after test.	PASS
