Test Report

Report No. A2190223226101

Sample Name RFCT-BNC-CAP-GS-2,RFCT-N-CAP-GS-1,RFCT-TNC-CAP-GS-2,RFCT-SMA-CAP-GS-1
Type cap
Sample Receiving State Normal
Sample Received Date Aug. 27, 2019
Testing Period Aug. 27, 2019-Sep. 2, 2019

No.	Test Item
1	IPX7
2	IP6X

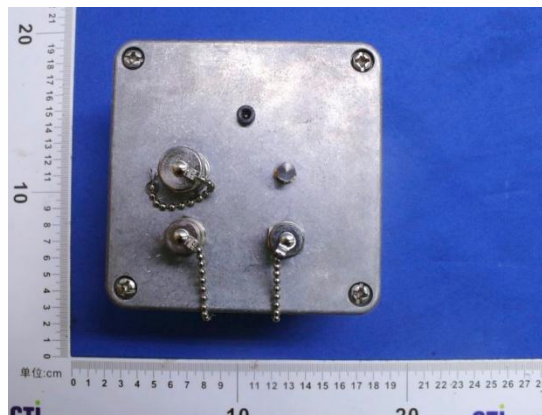
Sample No.	Sample Name	Type	Quantity
A2190223226101001	RFCT-BNC-CAP-GS-2,RFCT-N-CAP-GS-1,RFCT-TNC-CAP-GS-2,RFCT-SMA-CAP-GS-1	cap	1pc

Sample Photo(s)

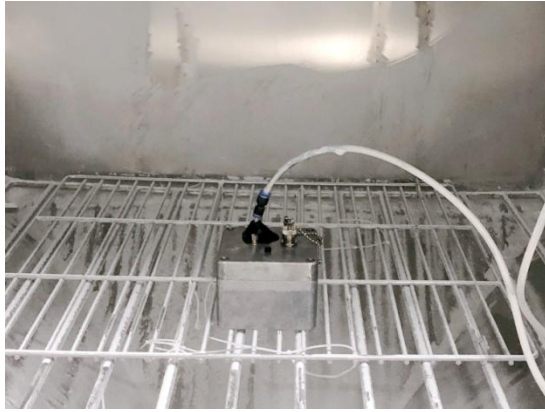
A2190223226101001

Test Photo(s)

1. Using a test probe with a diameter of 1 mm, apply a force of 1 N to probe the gap portion of the sample.

2. Put the sample under negative pressure (extraction rate: 864mL/min, 40~60 times of shell volume per hour; pressure inside the shell and atmospheric pressure: 0.5 kPa) and put it in a dust test chamber containing 2kg/m³ talcum powder. in.

3. Test time: 2 hours.

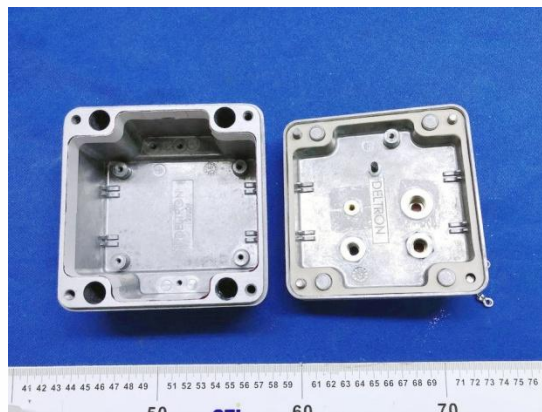
A2190223226101001

Sample No.	Criterion	Test result(Visual inspection)	Conclusion
A219022322610100101	The test probe cannot enter the inside of the sample, and the inside of the sample is dust-free.	The test probe cannot enter the inside of the sample, and the inside of the sample is dust-free.	Pass

Sample Photo(s) after the test
