Report No. A223054740410101

Sample Name	Ipex MHF I to 1.13 cable to RP SMA S/T Bulkhead Jack w/o-ring	Ipex MHF I to 1.13 cable to SMAS/T Bulkhead Jack w/o-ring
Part No.	CAB603RF-XXXX-XX-X-1	CAB602RF-XXXX-XX-X-1
Sample Receiving State	Normal	Normal
Sample Received Date	Oct. 23, 2023	
Testing Period	Oct. 23, 2023-Oct. 30, 2023

No.	Test Item
1	IPX7

Test Report

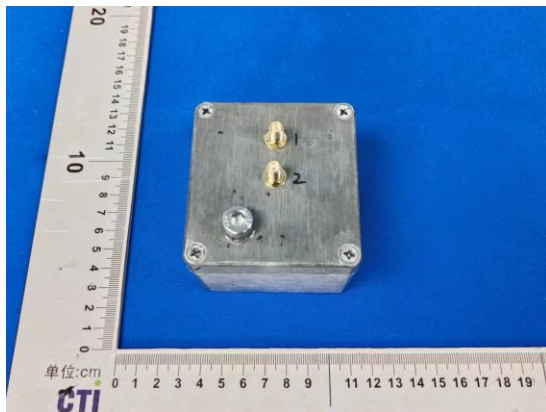
A2230547404101001

Sample Photo(s)

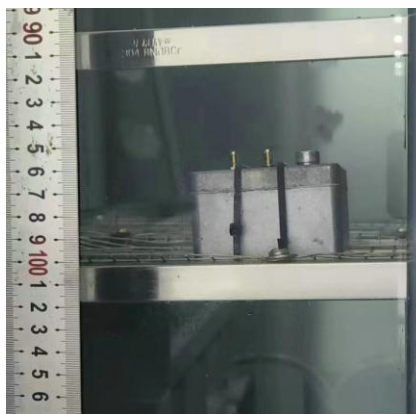
The lowest point of the sample is located 1000 mm below the surface of the water.

Test duration:30min

Test Photo(s)

Sample No.	Criterion	Test result (Visual inspection)	Conclusion
A2230547404101001	There is no water inside the sample, if there is water can not enter or endanger live parts.	No water enters the sample	Pass
A2230547404101002	There is no water inside the sample, if there is water can not enter or endanger live parts.	No water enters the sample	Pass

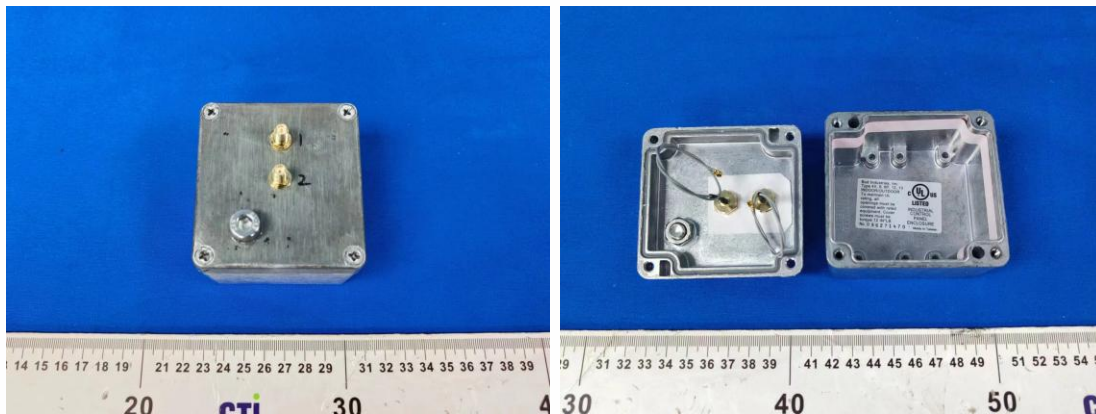
A2230547404101001

Sample Photo(s) after the test
