Sample Name	Stainless Steel SMA Right Angle Bulkhead Jack	Stainless Steel SMA Right Angle Bulkhead Jack
Type	RFPC-SMA22-FN-A-E	RFPC-SMA22-FN-A-S
Sample Receiving State	Normal	Normal
Sample Received Date	Feb. 22, 2023	
Testing Period	Feb. 22, 2023-Mar. 7, 2023

No.	Test Item
1	IP6X

# Test Report

Report No. A223006571810103

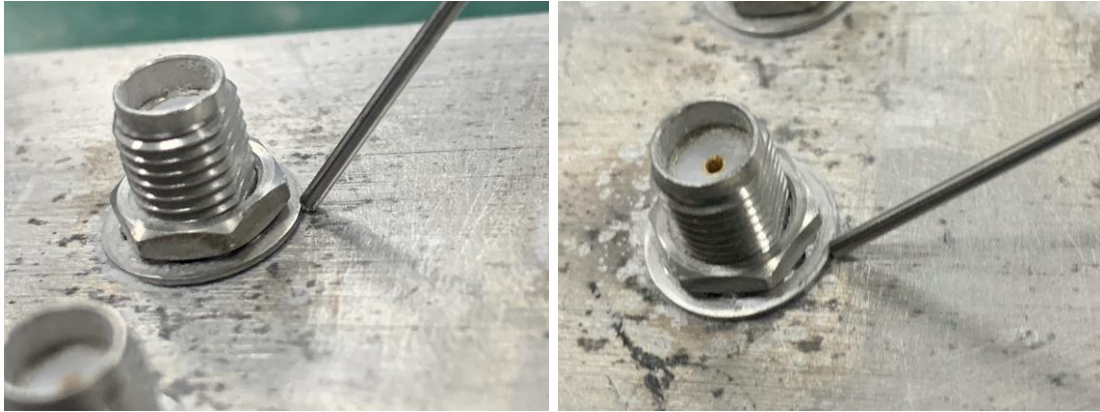
Use a test probe with a diameter of 1mm to probe the gap part of the sample with a force of 1N  
Put the sample in a negative pressure state, the pumping rate is 40-60 times the volume of the shell per hour, and the pressure difference between the pressure in the shell and the atmospheric pressure is less than 2kPa, and the test is continuously performed for 2h in the dust-proof test box.

## Test Photo(s)

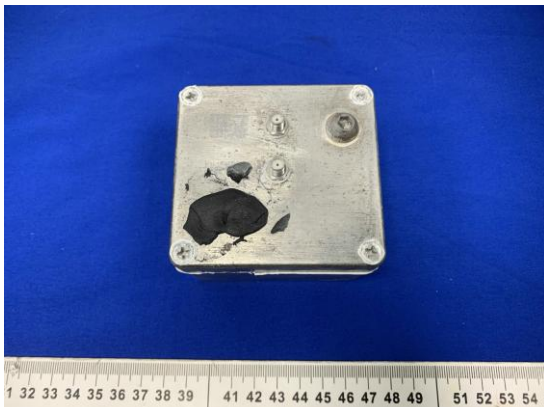
A2230065718101001~A2230065718101002

Sample No.	Criterion	Test Results(Visual inspection)	Conclusion
A2230065718101001	The test probe cannot enter the inside of the sample, and there is no dust inside the sample.	The test probe does not enter the interior of the sample, and no dust enters the interior	Pass
A2230065718101002		The test probe does not enter the interior of the sample, and no dust enters the interior	Pass

## Sample Photo(s) after the test
