Test Report

Report No.A223006571810102Page 1 of 5Company Name
Shown on ReportGradConn LtdAddress209 Minsheng Road, Longtan District, Taoyuan City, Taiwan 32554

| Sample Name | Stainless Steel SMA Right Angle Bulkhead Jack | Stainless Steel SMA Right Angle Bulkhead Jack |

| No. | Test Item |
|---|---|
| 1 | ІРХ9К |

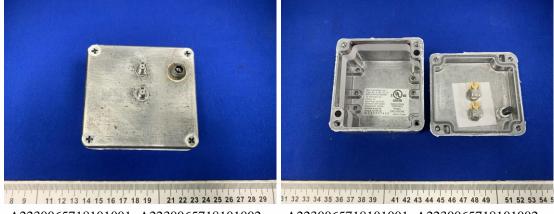
A2230065718101001~A2230065718101002

| Sample No. | Criterion | Test Results(Visual inspection) | Conclusion | |
|---|---|---|---|--|
| A2230065718101001 | No water enters inside the sample | No water enters inside the sample | Pass | |
| A2230065718101002 | | No water enters inside the sample | Pass | |

Sample Photo(s) after the test
