Sample Name SMA Bulkhead Jack with O-ring
Type RFPC-SMA23-FN-186
Sample Receiving State Normal
Sample Received Date Apr. 27, 2023
Testing Period Apr. 27, 2023-May 15, 2023

No.	Test Item
1	IP6X

Test Report

3. Test Standard: IEC 60529:2013**4. Test Condition**

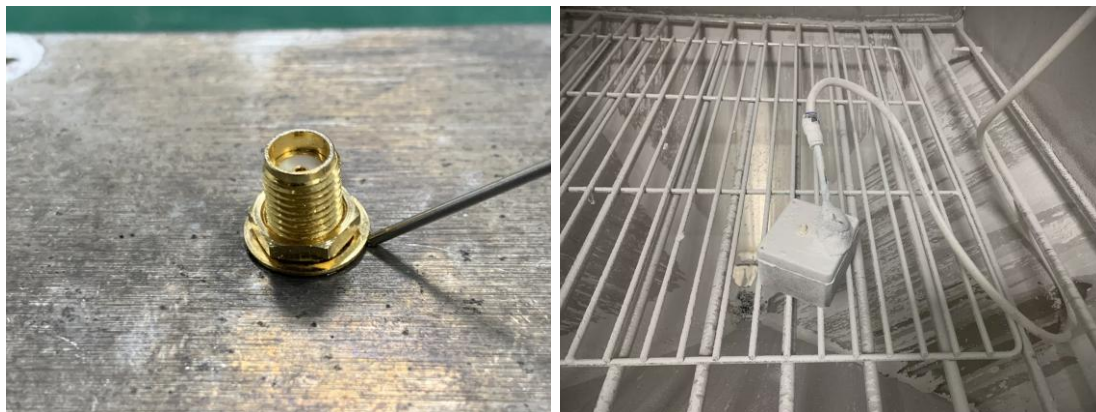
A2230196258101001

Use a test probe with a diameter of 1mm to probe the gap part of the sample with a force of 1N
Put the sample in a negative pressure state, the pumping rate is 40-60 times the volume of the shell per hour, and the pressure difference between the pressure in the shell and the atmospheric pressure is less than 2kPa, and the test is continuously performed for 2h in the dust-proof test box.

Test Photo(s)
