Report No. A223050212310103

Sample Name Stainless Steel RP SMA Right Angle Bulkhead Jack with O-ring  
Type RFPC-SMA24-FN  
Sample Receiving State Normal  
Sample Received Date Sep. 25, 2023  
Testing Period Sep. 25, 2023-Oct. 13, 2023

| No. | Test Item |
|---|---|
| 1 | IP6X |

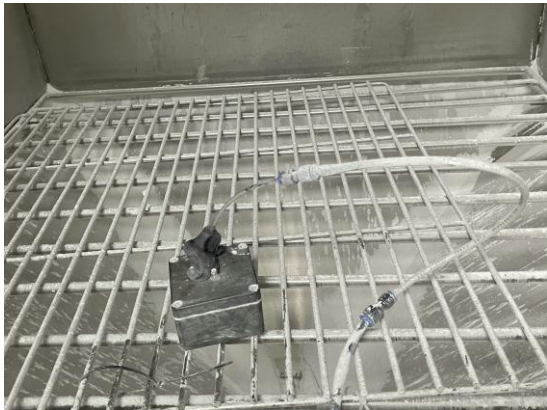
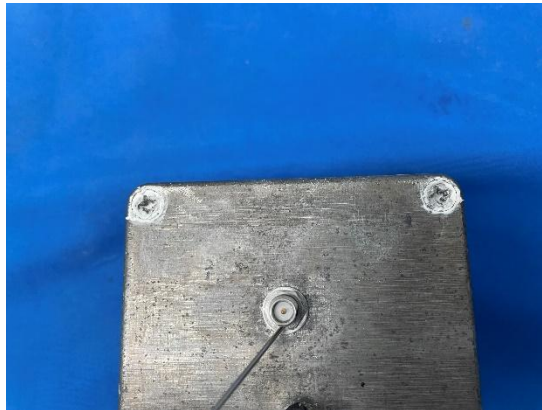
A2230502123101001

Use a test probe with a diameter of 1mm to probe the gap part of the sample with a force of 1N.

Put the sample in a negative pressure state, the pumping rate is 40~60 times the volume of the shell per hour, and the pressure difference between the pressure in the shell and the atmospheric pressure is less than 2kPa, and the test is continuously performed for 2h in the dust-proof test box.

### Test Photo(s)

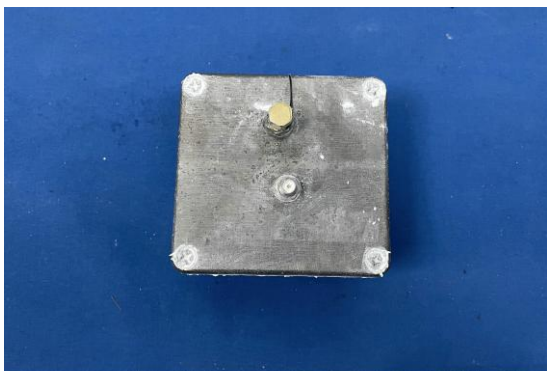
| Sample No. | Criterion | Test result<br>(Visual inspection) | Conclusion |
|---|--|--|---|
| A2230502123101001 | The probe cannot enter the sample, and there is no dust inside the sample. | The probe cannot enter the sample, and there is no dust inside the sample. | Pass |

### Sample Photo(s) after the test
